Advanced Scratch Test Module for Platform 5 NanoTest Vantage

Introduction

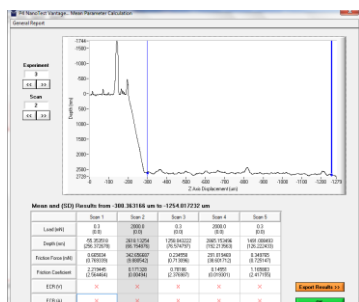
Mean and SD of depth and friction data for every scan in a multi-pass scratch test from user-defined region

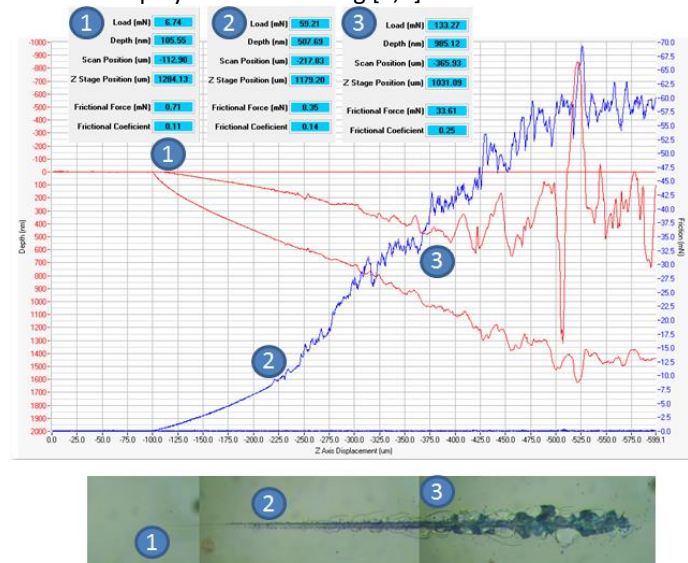
3-scan tests on 80 nm PVD ta-C coating on glass

The figure above shows an example on the 80 nm ta-C on glass where the load is ramped linearly to 200 mN and the depth data has been corrected for slope and compliance following the method developed in [1-3]. The ta-C coating is thin, hard and stiff ($H = 25 \text{ GPa}$, $E = 175 \text{ GPa}$, ISO14577-4 measurements performed with a sharp cube corner indenter to ensure full plasticity in the coating before substrate yield). In the scratch tests with the $3.8 \mu\text{m}$ probe the ta-C yields at low load (point 1 in figure) despite having high H^3/E^2 due to plastic yield occurring in the softer glass substrate. Coating failure occurred at higher load due to high coating bending.

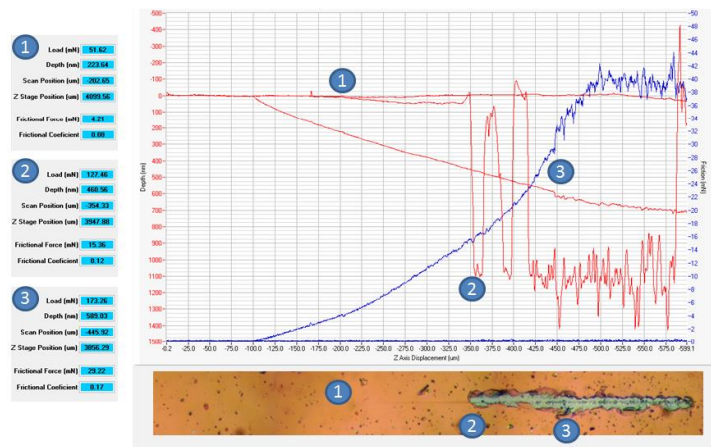
3-scan tests on 1.1 μm PVD nc-TiN/Si₃N₄ coating on Si

1 = onset of plasticity, 2 = delamination 3 = compressive failure

In the above example on the thicker nc-TiN/Si₃N₄ coating on Si(100) with $H = 28.9$ GPa and $E = 425$ GPa, the load for yield is much larger. Analysis shows yielding within the coating. The high H/E and H^3/E^2 of the coating resulted in delamination around the scratch track.

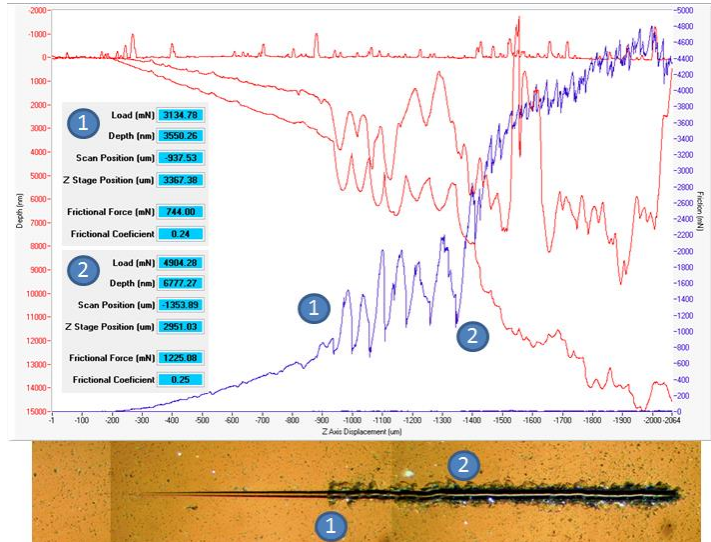
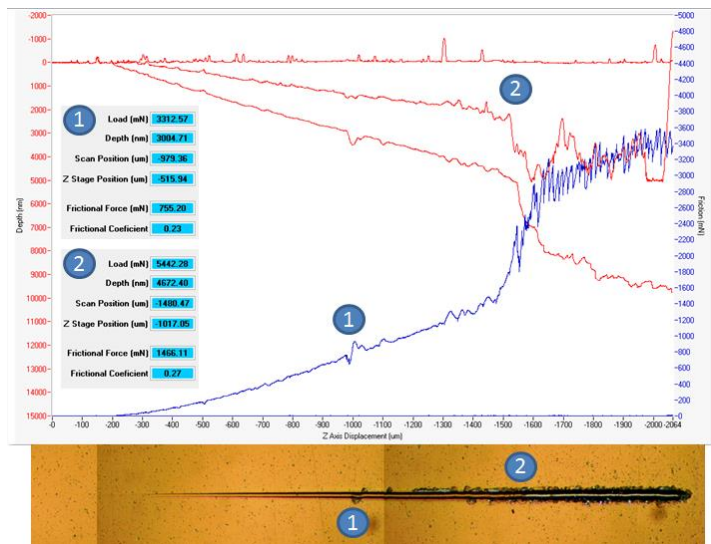
The figures above show typical data from ramped tests to 7.5 N after correction for slope and compliance. The increased load support shown in the duplex coating results in less chipping and higher critical loads.

With the 30 N head it is possible to test thicker coatings and also investigate the influence of hardened sub-layers on scratch test critical loads and failure mechanisms. Ramped load scratch tests performed as 3-pass topography-scratch-topography tests with a $R = 25\ \mu\text{m}$ radius spherical diamond indenter on $2\ \mu\text{m}$ TiN PVD coatings with high surface roughness on (i) D2 tool steel and (ii) ion-nitrided D2 tool steel.

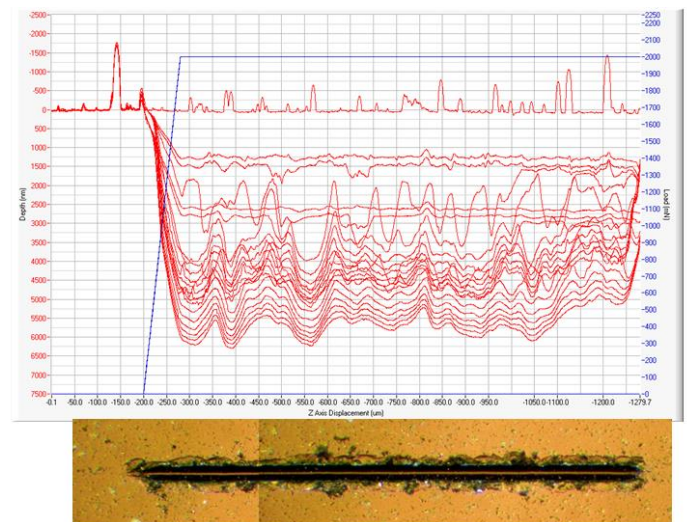
Correlation between friction (blue) and topography (red) in scans before (left) and after failure (right)

Multi-pass tests involving 10 scratches at 2 N were performed on the TiN deposited on un-modified tool steel. Repetitive sub-critical load tests were performed on the non-nitrided TiN. These involved 21 scans with 10 scratches and 11 intermediate topography scans set up as:-
